98% SUCCESS OF **MODE** **IMPLANT** SYSTEM

Since 2012 I am using Mode Medical Products in my clinic. I applied up to 1500 Mode Implants my patients. I am trying to file and follow my cases meticulously. I am very satisfied with the results of 5 years follow-up cases with up to %98 success rate.

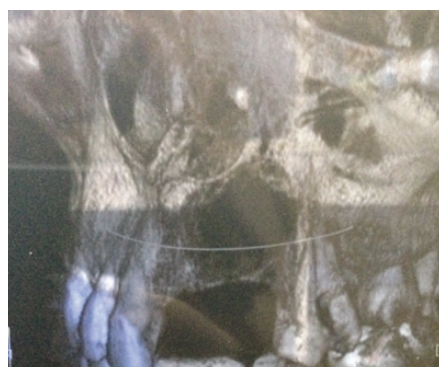
Photo 1: Bone defect after cyst enucleation

22 years old male patient referred to our clinic with fossa canine abscess. After clinic and radiographic examination cystic lesion detected at the right incisor area. Cyst enucleated immediately but unfortunately the related teeth had to be extracted. The pathologic investigation resulted as radicular cyst. After healing prosthetic rehabilitation discussed. The decision was implant supported fixed prosthesis. but the residual bone was insufficient. The vestibular bone Wall was vanished and there was a dehiscence defect at the palatal Wall. 3D bone augmentation with mandibular ramus bone block graft was planned. 4 months after fist surgery implants were placed. Waited for 3 months for osteointegration and final prosthesis applied.

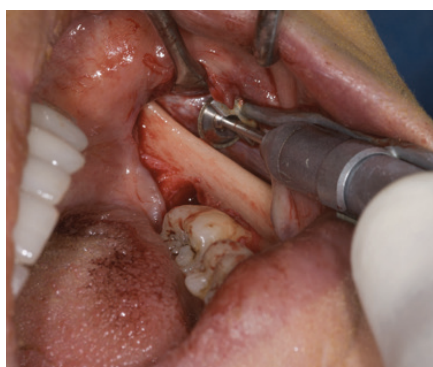
Photo 2: Harvesting bone block from ramus of mandibula

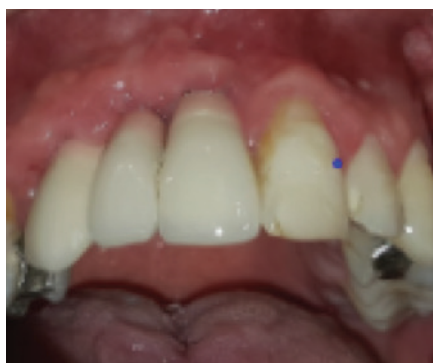
Photo 5: Final intra oral view
