98% SUCCESS OF **MODE** **IMPLANT** SYSTEM

Since 2012 I am using Mode Medical Products in my clinic. I applied up to 1500 Mode Implants my patients. I am trying to file and follow my cases meticulously. I am very satisfied with the results of 5 years follow-up cases with up to %98 success rate.

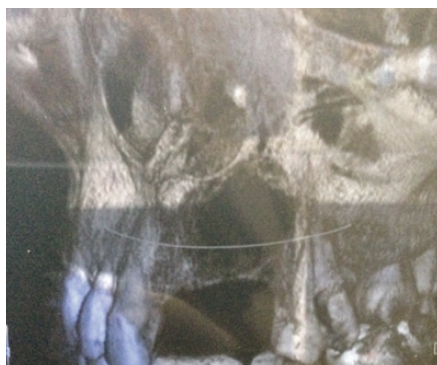
Photo 1: Bone defect after cyst enucleation

22 years old male patient referred to our clinic with fossa canine abscess. After clinic and radiographic examination cystic lesion detected at the right incisor area. Cyst enucleated immediately but unfortunately the related teeth had to be extracted. The pathologic investigation resulted as radicular cyst. After healing prosthetic rehabilitation discussed. The decision was implant supported fixed prosthesis. but the residual bone was insufficient. The vestibular bone Wall was vanished and there was a dehiscence defect at the palatal Wall. 3D bone augmentation with mandibular ramus bone block graft was planned. 4 months after fist surgery implants were placed. Waited for 3 months for osteointegration and final prosthesis applied.

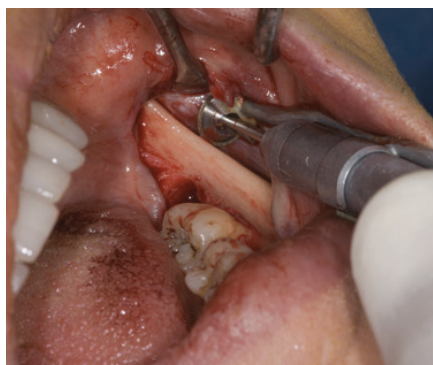
Photo 2: Harvesting bone block from ramus of mandibula

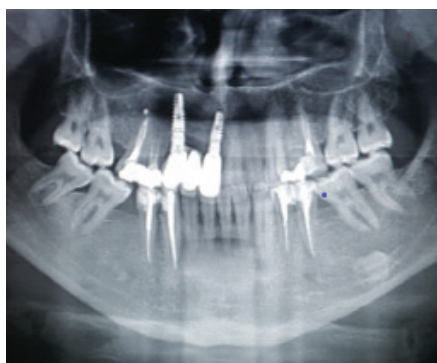
Photo 4: Radiography of implants with prosthetic rehabilitation
