**ATATÜRK UNIVERSITY  
ENGINEERING FACULTY  
DEPARTMENT OF MECHANICAL  
ENGINEERING**

**DENTAL IMPLANT SYSTEM**

**FATIGUE TEST**

**BIOMECHANICAL TEST RESULTS (Rev. 01)  
(ISO 14801)**

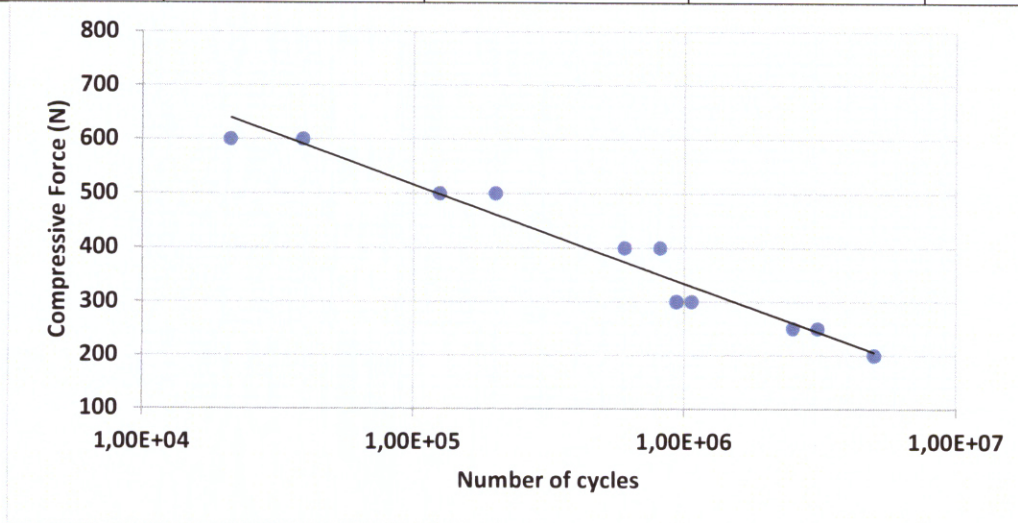
Figure 3. Load-Number of cycles diagram

Specimen	Minimum Load (N)	Maximum Load (N)	Number of Cycles	Result
1	70	700	1	Failure
2	70	700	1	Failure
3	60	600	21206	Failure
4	60	600	39178	Failure
5	50	500	125472	Failure
6	50	500	201389	Failure
7	40	400	812563	Failure
8	40	400	701418	Failure
9	30	300	935492	Failure
10	30	300	1062743	Failure
11	20	200	2512811	Failure
12	20	200	3101760	Failure
13	18	180	5000000	No failure
14	18	180	5000000	No failure
15	18	180	5000000	No failure

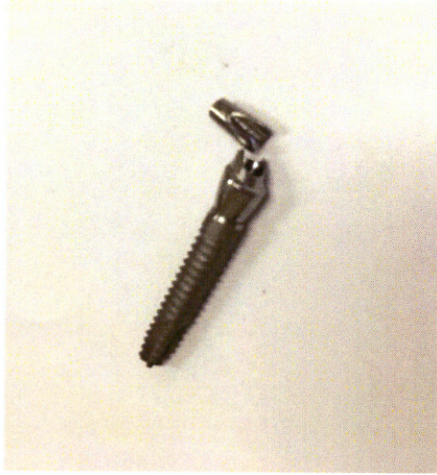
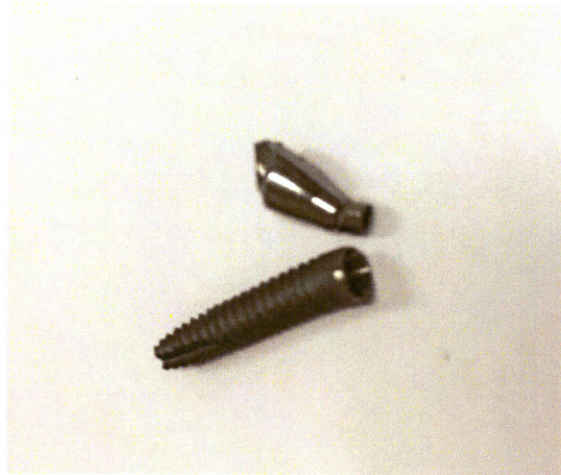
**Fig. 4.** Sample failure modes in dental implants: fracture of inter-connection screw (a) and abutment failure (b)

Fractures, which are emerged in the implants, have been observed in the screws, which are fixed within the implant (Figure 4). The load applied to angled abutments caused to initiate crack in abutment-implant connection screws and subsequently, fracture was observed in these screws. However, two specimens were fractured at their abutment where its angle has changed suddenly. Also, maximum load value has been determined as 180 N and correspondingly, maximum bending moment value has been calculated a value of 535.5 Nmm (0.5355 Nm). As clearly seen from examinations, the failure was occurred only inter connection screws and any fracture was not observed on dental implants.
